**Flood Control Project Maintenance
Levee Inspections**
LMA District Cover Sheet
Spring 2017 Levee Inspection Results

Lake County Watershed Protection District

Spring 2017 Levee Inspection Results

Waterway			Bank	Unit Miles
Unit No. 01 Middle Creek			Left	3.35
	Spring (March - May)	Summer (June - August)	(September - November) Fall	Winter (December - February)
Unit Maintenance Rating (Fall Only)				
Date of Inspection	4/4/2017 - 4/4/2017			
DWR Inspector	Bob Duffey			
Accompanied By	Will Evans Lake County

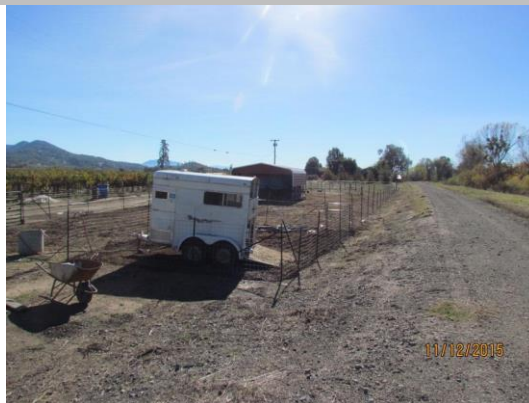
Photo 1 of 1 : SP_2017_NA0009_3_24_20170315_00014.jpg

LM Start	0.14	Rating **	M	Issue No.	24
LM End	0.22	Issue Type +	En	Location *	LS
Category	Earthen Levee			GPS Latitude/Longitude	
				Start	End
Item	Encroachments			39.188465 °	39.187392 °
				-122.907687 °	-122.907885 °
DWR ID	DWR_NA0009_01_f_2015_24				
Comment Code					
FE : Fence					
Inspector Comment					
Remove the fence from the landside toe.

View of the fence along the landside toe.

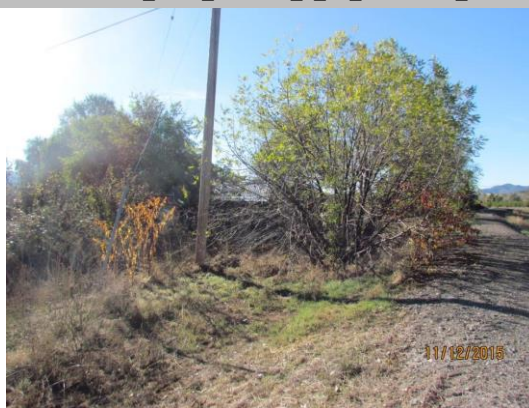
Photo 1 of 1 : SP_2017_NA0009_3_11_20170315_00006.jpg

LM Start	0.26	Rating **	M	Issue No.	11
LM End	0.26	Issue Type +	Ma	Location *	LS
Category	Earthen Levee			GPS Latitude/Longitude	
				Start	End
Item	Trim / Thin Trees			39.186777 °	39.186777 °
				-122.908102 °	-122.908102 °
DWR ID	DWR_NA0009_01_s_2013_11				
Comment Code					
T3 : Trim and thin trees to allow visibility of the ground and room to flood fight.					
Inspector Comment

View of the overgrown trees at the landside slope.

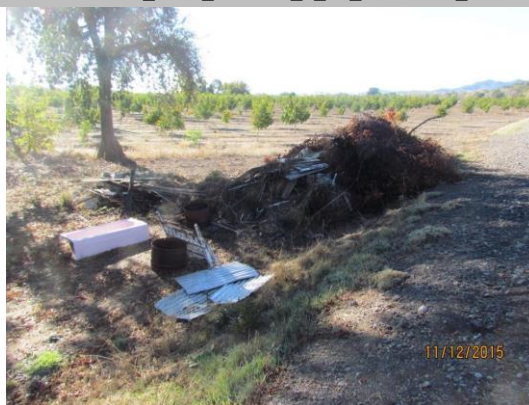
Photo 1 of 1 : SP_2017_NA0009_3_21_20170315_00012.jpg

LM Start	0.32	Rating **	M	Issue No.	21
LM End	0.32	Issue Type +	En	Location *	LS
Category	Earthen Levee			GPS Latitude/Longitude	
				Start	End
Item	Encroachments			39.186055 °	39.186055 °
				-122.908583 °	-122.908583 °
DWR ID	DWR_NA0009_01_f_2015_21				
Comment Code					
PR : Prunings					
Inspector Comment					
Remove the prunings from the landside slope.

Remove the prunings from the landside slope.

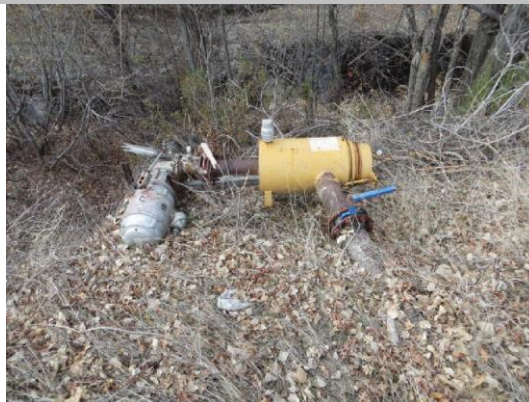
Photo 3 of 3 : UCIP_SP_2017_26946_49787.jpg

LM Start	0.84	Rating **	M	Issue No.	536 (cont)	
LM End	0.84	Issue Type +	En	Location *	LS	
Category	Supplemental			GPS Latitude/Longitude		
				Start		End
Item	DWR UCIP Field Study			39.179534 °	39.179534 °	
				-122.912512 °	-122.912512 °	
DWR ID						
Comment Code						
Inspector Comment						
FS_ID:26946						
DS_ID:21196						
EP_NO: N/A						
Repair Type: Non-Urgent						
Crossing Status: Found						
UCIP Comments: Pump and pipe appear abandoned and should be done so properly.						
FIELD_STRUCT_DESC: *ABANDONED* 8-inch steel irrigation pipe through the levee, 3.0 feet below the crown. Siphon breaker in 24-inch CMP riser on landward slope. Pump on the waterward bank with a butterfly valve. Service pole on the waterward berm. (USACE-1961). This entry matches the Drainage or Irrigation Structure referenced in O&M manual (HLM 0.83).						
FS Date: 1/9/2014

Pump and butterfly valve visible on WS berm.

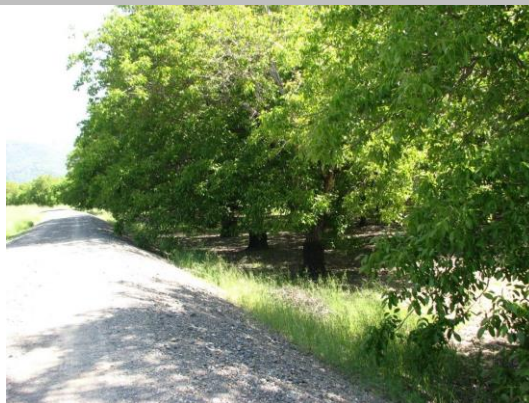
Photo 1 of 1 : SP_2017_NA0009_3_27_20170315_00017.jpg

LM Start	1.15	Rating **	M	Issue No.	27
LM End	1.41	Issue Type +	En	Location *	LS
Category	Earthen Levee			GPS Latitude/Longitude	
				Start	End
Item	Encroachments			39.175465 °	39.172077 °
				-122.912012 °	-122.914226 °
DWR ID	DWR_NA0009_01_s_2016_27				
Comment Code					
TR : Tree or limb					
Inspector Comment					
Orchard trees should be trimmed to 5' above LS slope.

5/2/2016: Trip trees on L/S slope.

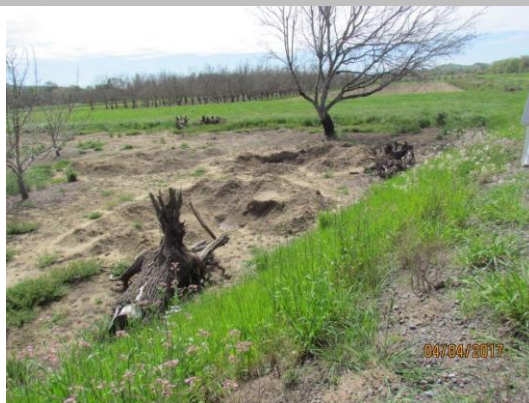
Photo 1 of 1 : SP_2017_NA0009_3_35_20170410_00037.jpg

LM Start	1.53	Rating **	M	Issue No.	35
LM End	1.53	Issue Type +	En	Location *	LS
Category	Earthen Levee			GPS Latitude/Longitude	
				Start	End
Item	Encroachments			39.170428 °	39.170428 °
				-122.914948 °	-122.914948 °
DWR ID	DWR_NA0009_01_s_2017_35				
Comment Code					
TR : Tree or limb					
Inspector Comment					
Remove the tree stumps from the landside toe.

View of the tree stumps along the landside toe.

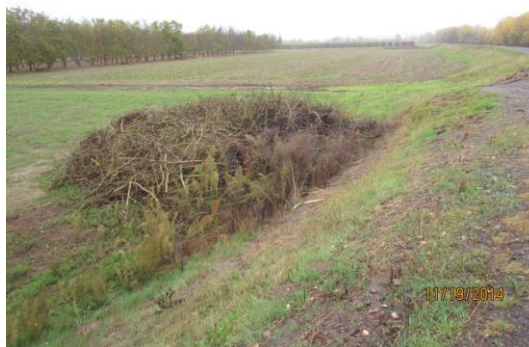
Photo 1 of 1 : SP_2017_NA0009_3_290_20170315_00020.jpg

LM Start	1.57	Rating **	A/W	Issue No.	290
LM End	1.57	Issue Type +	En	Location *	LS
Category	Earthen Levee			GPS Latitude/Longitude	
				Start	End
Item	Encroachments			39.169918 °	39.169918 °
				-122.915197 °	-122.915197 °
DWR ID	DWR_NA0009_01_f_2014_290				
Comment Code					
PR : Prunings					
Inspector Comment

View of the prunings along the landside toe.

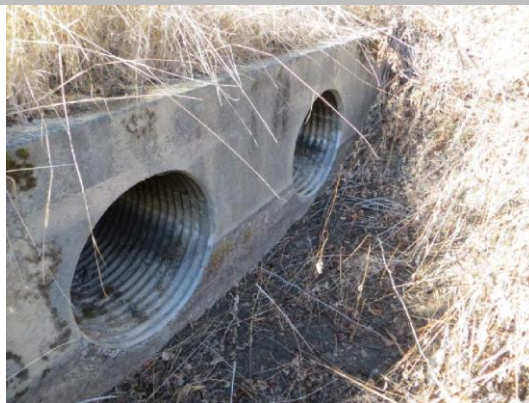
Photo 2 of 3 : UCIP_SP_2017_26986_49848.jpg

FS_ID:26986
DS_ID:21197
EP_NO: N/A
Repair Type: No Action Needed
Crossing Status: Found
UCIP Comments:
FIELD_STRUCT_DESC: 1 of 2: 36-inch CM drainpipe through the levee, 9.0 feet below the crown. Flap gate on the waterward end. Concrete "U" headwalls on both ends. Originally listed in 1961 O+M manual. Pipes retained through levee under ABO No. 11460 (1975).
FS Date: 1/9/2014

Concrete headwall and pipe visible on LS toe.

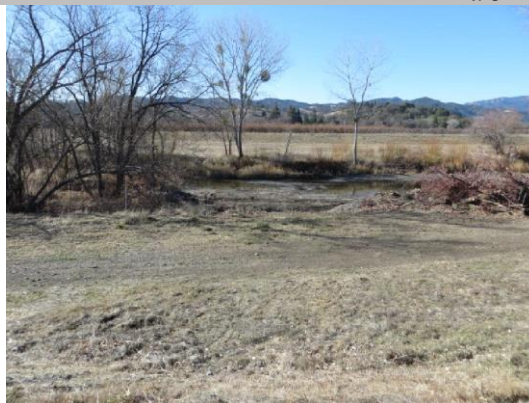
Photo 3 of 3 : UCIP_SP_2017_26986_49847.jpg

LM Start	2.26	Rating **	A/W	Issue No.	538 (cont)
LM End	2.26	Issue Type +	Ma	Location *	LS
Category	Supplemental			GPS Latitude/Longitude	
				Start	End
Item	DWR UCIP LMA Responsibility			39.160272 °	39.160272 °
				-122.913966 °	-122.913966 °
DWR ID					
Comment Code					
Inspector Comment					
FS_ID:26986					
DS_ID:21197					
EP_NO: N/A					
Repair Type: No Action Needed					
Crossing Status: Found					
UCIP Comments:					
FIELD_STRUCT_DESC: 1 of 2: 36-inch CM drainpipe through the					
levee, 9.0 feet below the crown. Flap gate on the waterward end.					
Concrete "U" headwalls on both ends. Originally listed in 1961 O+M					
manual. Pipes retained through levee under ABO No. 11460 (1975).					
FS Date: 1/9/2014

Concrete headwall and pipe visible on WS berm.

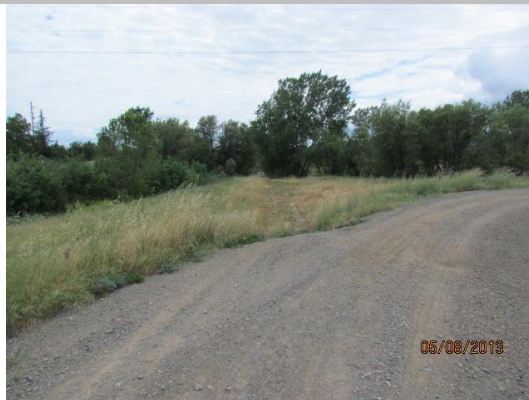
Photo 1 of 1 : SP_2017_NA0009_3_13_20170315_00007.jpg

LM Start	2.29	Rating **	M	Issue No.	13
LM End	2.29	Issue Type +	Ma	Location *	WS
Category	Earthen Levee			GPS Latitude/Longitude	
				Start	End
Item	Slope Stability			39.160285 °	39.160285 °
				-122.913481 °	-122.913481 °
DWR ID	DWR_NA0009_01_s_2013_13				
Comment Code					
S3 : Repair the levee slope damaged by vehicle traffic and prevent access where possible.					
Inspector Comment

View of the vehicle erosion along the waterside slope.

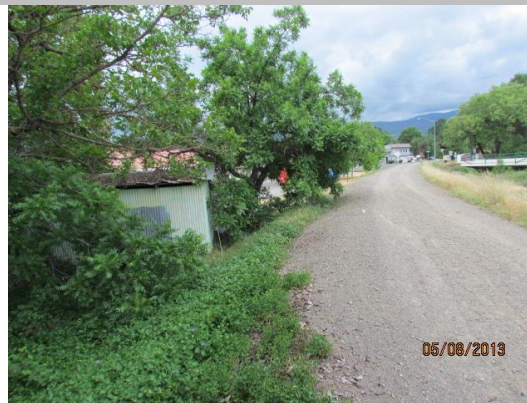
Photo 1 of 1 : SP_2017_NA0009_3_15_20170315_00009.jpg

LM Start	2.38	Rating **	M	Issue No.	15
LM End	2.41	Issue Type +	Ma	Location *	LS
Category	Earthen Levee			GPS Latitude/Longitude	
				Start	End
Item	Trim / Thin Trees			39.161381 °	39.161708 °
				-122.912551 °	-122.912168 °
DWR ID	DWR_NA0009_01_s_2013_15				
Comment Code					
T1 : Trim trees to at least five feet above ground level.					
Inspector Comment

Trim the trees up 5 feet to allow visibility.

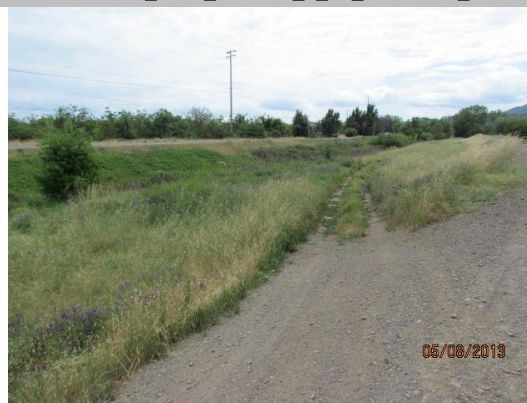
Photo 1 of 1 : SP_2017_NA0009_3_16_20170315_00010.jpg

LM Start	2.40	Rating **	M	Issue No.	16
LM End	2.40	Issue Type +	Ma	Location *	WS
Category	Earthen Levee			GPS Latitude/Longitude	
				Start	End
Item	Slope Stability			39.161601 °	39.161601 °
				-122.912303 °	-122.912303 °
DWR ID	DWR_NA0009_01_s_2013_16				
Comment Code					
S3 : Repair the levee slope damaged by vehicle traffic and prevent access where possible.					
Inspector Comment

View of the vehicle erosion along the waterside slope.

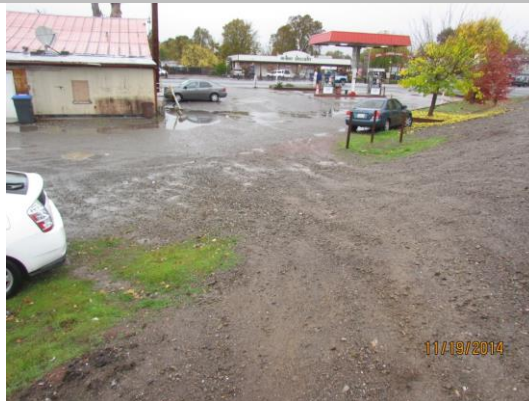
Photo 1 of 1 : SP_2017_NA0009_3_17_20170315_00011.jpg

LM Start	2.42	Rating **	M	Issue No.	17
LM End	2.42	Issue Type +	Ma	Location *	LS
Category	Earthen Levee			GPS Latitude/Longitude	
				Start	End
Item	Slope Stability			39.161802 °	39.161802 °
				-122.912020 °	-122.912020 °
DWR ID	DWR_NA0009_01_s_2013_17				
Comment Code					
S3 : Repair the levee slope damaged by vehicle traffic and prevent access where possible.					
Inspector Comment

View of the erosion caused by vehicle along the landside slope.

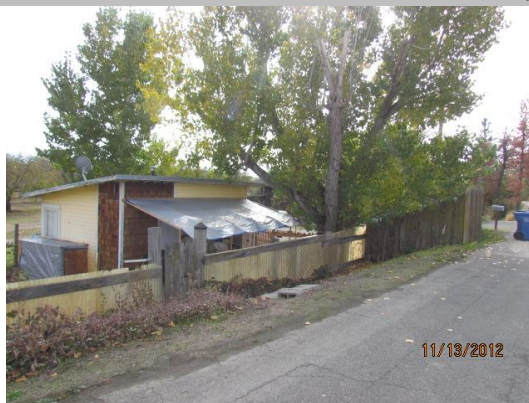
Photo 1 of 1 : SP_2017_NA0009_3_7_20170315_00005.jpg

LM Start	2.47	Rating **	M	Issue No.	7
LM End	2.59	Issue Type +	En	Location *	LS
Category	Earthen Levee			GPS Latitude/Longitude	
				Start	End
Item	Encroachments			39.161692 °	39.160217 °
				-122.911748 °	-122.912957 °
DWR ID	DWR_NA0009_01_s_2012_7				
Comment Code					
BU : Building					
Inspector Comment

View of a building & fence along the toe of the levee.

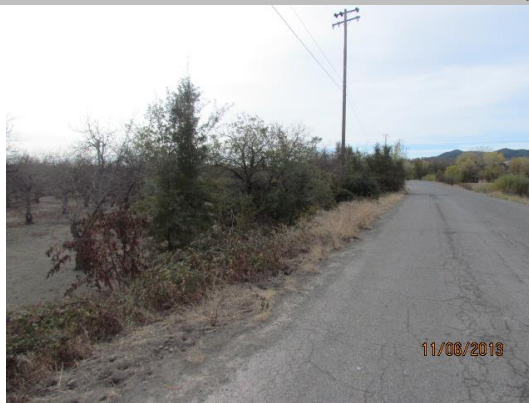
Photo 1 of 2 : SP_2017_NA0009_3_3_20170315_00001.jpg

LM Start	2.48	Rating **	U	Issue No.	3
LM End	2.55	Issue Type +	Ma	Location *	LS
Category	Earthen Levee			GPS Latitude/Longitude	
				Start	End
Item	Vegetation			39.161615 °	39.160804 °
				-122.911733 °	-122.912536 °
DWR ID	DWR_NA0009_01_s_2012_3				
Comment Code					
V2 : Remove the wild growth other than native grasses from the levee slopes.					
Inspector Comment

View of the vegetation along the landside slope.

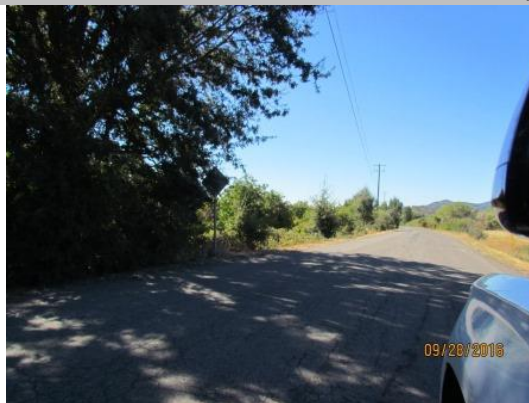
Photo 2 of 2 : SP_2017_NA0009_3_3_20170315_00002.jpg

LM Start	2.48	Rating **	U	Issue No.	3 (cont)	
LM End	2.55	Issue Type +	Ma	Location *	LS	
Category	Earthen Levee			GPS Latitude/Longitude		
				Start		End
Item	Vegetation			39.161615 °		39.160804 °
				-122.911733 °		-122.912536 °
DWR ID	DWR_NA0009_01_s_2012_3					
Comment Code						
V2 : Remove the wild growth other than native grasses from the levee slopes.						
Inspector Comment

View of the vegetation along the landside slope.

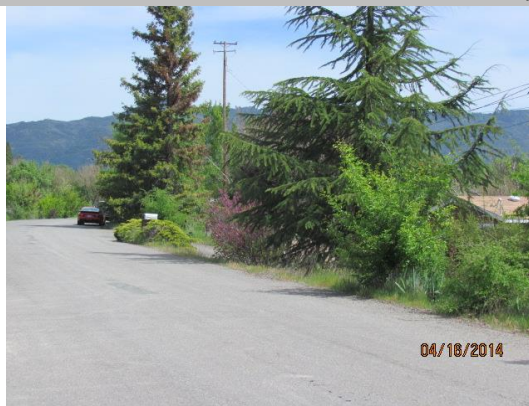
Photo 1 of 1 : SP_2017_NA0009_3_5_20170315_00004.jpg

LM Start	2.58	Rating **	M	Issue No.	5
LM End	2.66	Issue Type +	En	Location *	LS
Category	Earthen Levee			GPS Latitude/Longitude	
				Start	End
Item	Vegetation			39.160443 °	39.159308 °
				-122.912845 °	-122.913417 °
DWR ID	DWR_NA0009_01_s_2012_5				
Comment Code					
V6 : Landscaping					
Inspector Comment

View of the landscape along the landside slope.

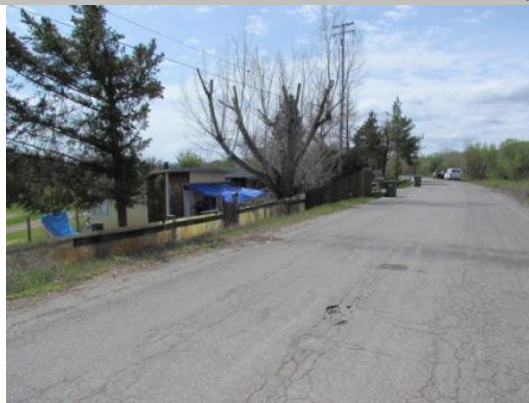
Photo 1 of 1 : SP_2017_NA0009_3_4_20170315_00003.jpg

LM Start	2.58	Rating **	M	Issue No.	4
LM End	2.61	Issue Type +	En	Location *	LS
Category	Earthen Levee			GPS Latitude/Longitude	
				Start	End
Item	Encroachments			39.160398 °	39.160020 °
				-122.912837 °	-122.913186 °
DWR ID	DWR_NA0009_01_s_2012_4				
Comment Code					
FE : Fence					
Inspector Comment

View of the fences at the Landside toe.

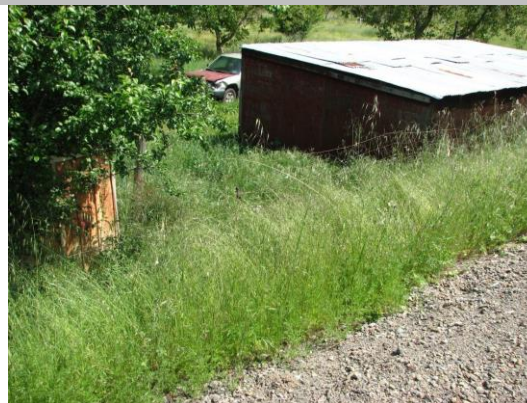
Photo 1 of 1 : SP_2017_NA0009_3_31_20170315_00018.jpg

LM Start	2.93	Rating **	U	Issue No.	31
LM End	2.93	Issue Type +	En	Location *	LS
Category	Earthen Levee			GPS Latitude/Longitude	
				Start	End
Item	Encroachments			39.155553 °	39.155553 °
				-122.914560 °	-122.914560 °
DWR ID	DWR_NA0009_01_s_2016_31				
Comment Code					
BU : Building					
Inspector Comment					
Two wooden sheds, one large, one small, with metal roofs.

5/2/2016: Remove or relocate 2 unpermitted sheds on L/S slope and toe.

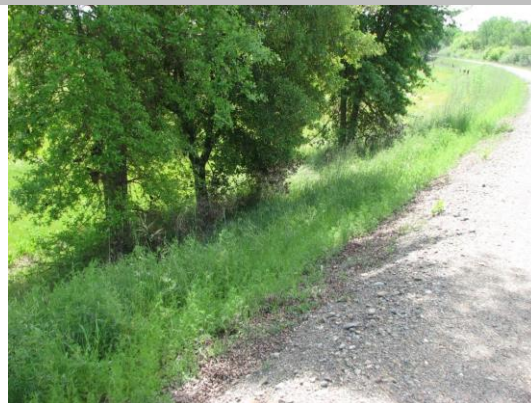
Photo 1 of 1 : SP_2017_NA0009_3_25_20170315_00015.jpg

LM Start	2.95	Rating **	M	Issue No.	25
LM End	2.95	Issue Type +	Ma	Location *	LS
Category	Earthen Levee			GPS Latitude/Longitude	
				Start	End
Item	Trim / Thin Trees			39.155301°	39.155301°
				-122.914633°	-122.914633°
DWR ID	DWR_NA0009_01_s_2016_25				
Comment Code					
T1 : Trim trees to at least five feet above ground level.					
Inspector Comment

Trim trees to 5' above levee slope (LS). 4/19/2016

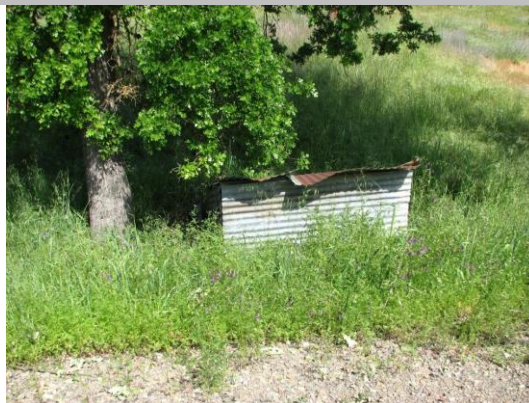
Photo 1 of 1 : SP_2017_NA0009_3_33_20170315_00019.jpg

LM Start	3.10	Rating **	U	Issue No.	33
LM End	3.10	Issue Type +	En	Location *	LS
Category	Earthen Levee			GPS Latitude/Longitude	
				Start	End
Item	Encroachments			39.153017 °	39.153017 °
				-122.914491 °	-122.914491 °
DWR ID	DWR_NA0009_01_s_2016_33				
Comment Code					
BU : Building					
Inspector Comment					
Small metal shed should be removed.

5/2/2016: Remove or relocate unpermitted shed on L/S toe.

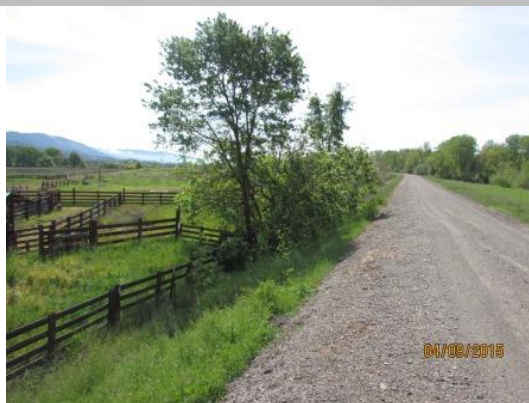
Photo 1 of 1 : SP_2017_NA0009_3_534_20170315_00021.jpg

LM Start	3.26	Rating **	M	Issue No.	534
LM End	3.26	Issue Type +	Ma	Location *	LS
Category	Earthen Levee			GPS Latitude/Longitude	
				Start	End
Item	Trim / Thin Trees			39.150957 °	39.150957 °
				-122.913504 °	-122.913504 °
DWR ID	DWR_NA0009_01_s_2015_534				
Comment Code					
T2 : Thin trees to allow visibility of the ground and room to flood fight.					
Inspector Comment

Remove the trees from the landside toe.

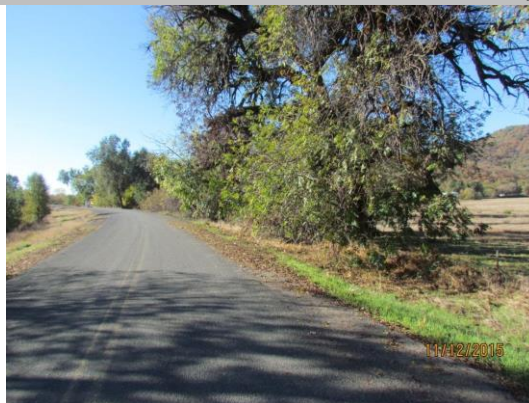
Photo 1 of 1 : SP_2017_NA0009_4_4_20170315_00004.jpg

LM Start	0.02	Rating **	M	Issue No.	4
LM End	0.14	Issue Type +	Ma	Location *	LS
Category	Earthen Levee			GPS Latitude/Longitude	
				Start	End
Item	Trim / Thin Trees			39.189540 °	39.187900 °
				-122.908065 °	-122.908655 °
DWR ID	DWR_NA0009_02_s_2013_4				
Comment Code					
T1 : Trim trees to at least five feet above ground level.					
Inspector Comment					
Trim the trees up 5 feet to allow visibility.

View of the overgrown trees at the landside toe.

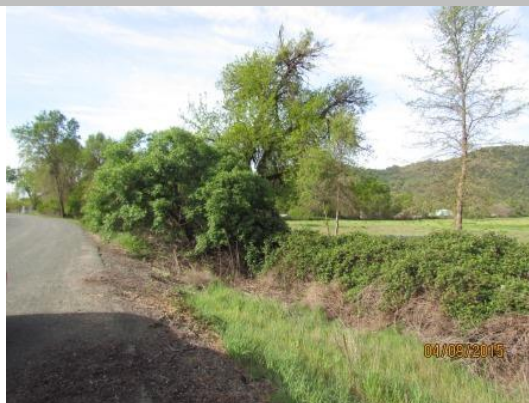
Photo 1 of 1 : SP_2017_NA0009_4_19_20170315_00010.jpg

LM Start	0.08	Rating **	M	Issue No.	19
LM End	0.08	Issue Type +	Ma	Location *	LS
Category	Earthen Levee			GPS Latitude/Longitude	
				Start	End
Item	Vegetation			39.188772 °	39.188772 °
				-122.908465 °	-122.908465 °
DWR ID	DWR_NA0009_02_s_2014_19				
Comment Code					
V4 : Elderberries are blocking visibility and flood fight capability.					
Inspector Comment

View of the elderberries along the landside toe.

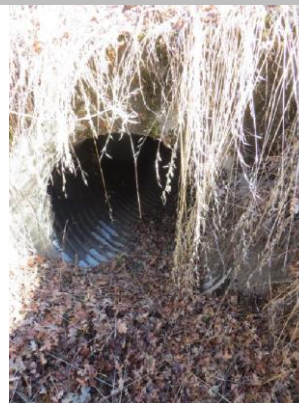
Photo 2 of 3 : UCIP_SP_2017_27066_50048.jpg

Pipe and headwall visible at LS toe in drainage swale.

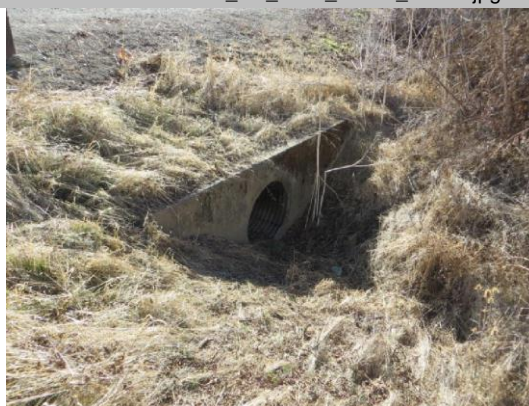
Photo 1 of 3 : UCIP_SP_2017_27184_50322.jpg

LM Start	0.24	Rating **	A/W	Issue No.	33
LM End	0.24	Issue Type +	Ma	Location *	LS
Category	Supplemental			GPS Latitude/Longitude	
				Start	End
Item	DWR UCIP LMA Responsibility			39.186794 °	39.186794 °
				-122.909413 °	-122.909413 °
DWR ID					
Comment Code					
Inspector Comment					
FS_ID:27184 DS_ID:21204 EP_NO: 11484 Repair Type: No Action Needed Crossing Status: Found UCIP Comments: FIELD_STRUCT_DESC: 36-inch CM drainpipe through the levee, 6 feet below the crown. Flap gate on the waterward end. Concrete headwalls on both ends. Originally included in 1961 O+M manual. This pipe was retained under ABO No. 11484 (1975). FS Date: 1/14/2014

Concrete headwall and pipe on LS toe.

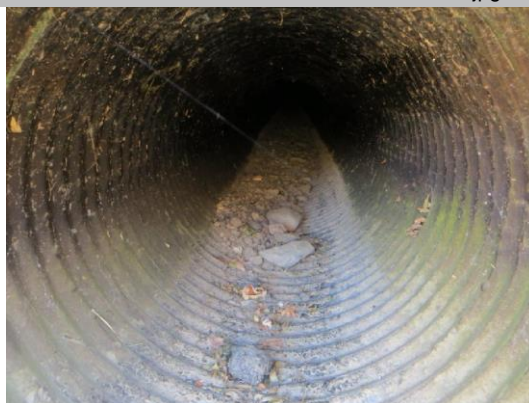
Photo 2 of 3 : UCIP_SP_2017_27184_50321.jpg

Pipe at inlet.

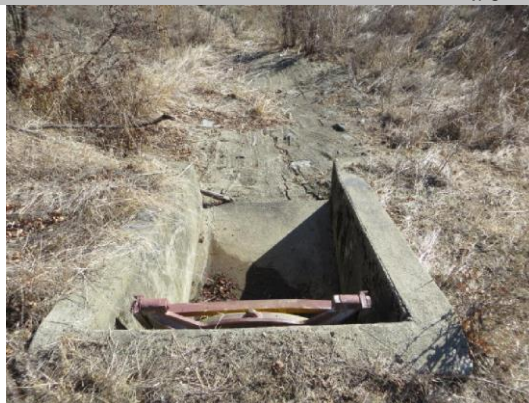
Photo 3 of 3 : UCIP_SP_2017_27184_50320.jpg

Flapgate and concrete headwall on WS toe.

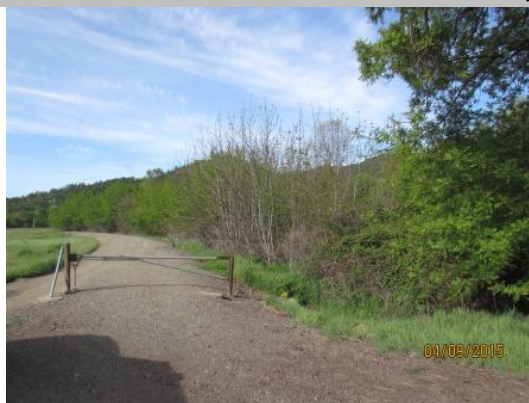
Photo 1 of 1 : SP_2017_NA0009_4_9_20170315_00006.jpg

LM Start	0.24	Rating **	M	Issue No.	9
LM End	0.27	Issue Type +	Ma	Location *	LS
Category	Earthen Levee			GPS Latitude/Longitude	
				Start	End
Item	Trim / Thin Trees			39.186739 °	39.186389 °
				-122.909436 °	-122.909821 °
DWR ID	DWR_NA0009_02_s_2013_9				
Comment Code					
T1 : Trim trees to at least five feet above ground level.					
Inspector Comment

View of the overgrown trees and vegetation at the landside toe.

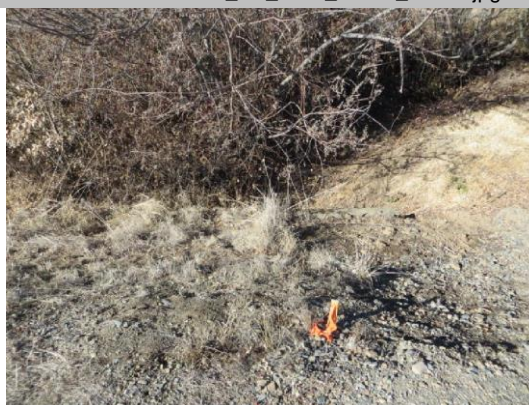
Photo 1 of 3 : UCIP_SP_2017_27192_50326.jpg

LM Start	0.39	Rating **	A/W	Issue No.	34
LM End	0.39	Issue Type +	Ma	Location *	LS
Category	Supplemental			GPS Latitude/Longitude	
				Start	End
Item	DWR UCIP LMA Responsibility			39.185174 °	39.185174 °
				-122.911171 °	-122.911171 °
DWR ID					
Comment Code					
Inspector Comment					
FS_ID:27192 DS_ID:21206 EP_NO: 11478 Repair Type: No Action Needed Crossing Status: Found UCIP Comments: FIELD_STRUCT_DESC: 42-inch CM drainpipe through the levee, 7.7 feet below the crown. Flap gate on the waterward end. Concrete headwalls on both ends. Grouted spillway over revetment on bank. (USACE-1961). This entry matches the Drainage or Irrigation Structure referenced in O&M manual (HLM 0.38). This pipe was retained under ABO No. 11478 (1975). FS Date: 1/14/2014

Pipe and concrete headwall at LS toe.

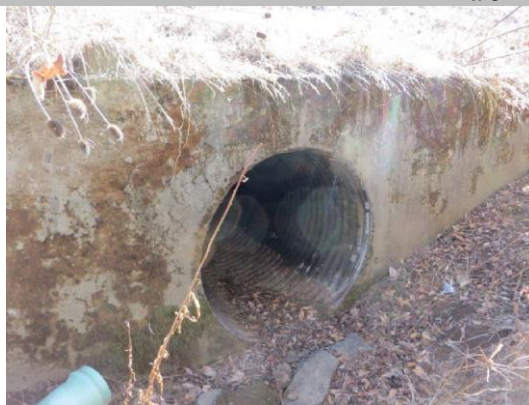
Photo 3 of 3 : UCIP_SP_2017_27192_50324.jpg

Pipe and concrete headwall at LS toe.

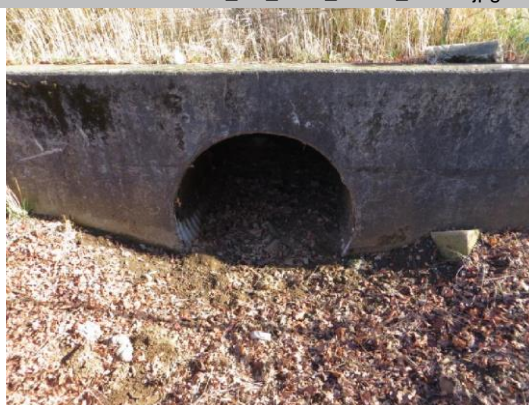
Photo 1 of 3 : UCIP_SP_2017_27199_50389.jpg

LM Start	0.48	Rating **	A/W	Issue No.	35
LM End	0.48	Issue Type +	Ma	Location *	LS
Category	Supplemental			GPS Latitude/Longitude	
				Start	End
Item	DWR UCIP LMA Responsibility			39.184126 °	39.184126 °
				-122.912118 °	-122.912118 °
DWR ID					
Comment Code					
Inspector Comment					
FS_ID:27199					
DS_ID:21208					
EP_NO: 11480					
Repair Type: No Action Needed					
Crossing Status: Found					
UCIP Comments:					
FIELD_STRUCT_DESC: 42-inch CM drainpipe through the levee, 7.0 feet below the crown. Flap gate on the waterward end. Concrete headwalls on both ends. (USACE-1961). This entry matches the Drainage or Irrigation Structure referenced in O&M manual (HLM 0.47). This pipe was retained under ABO No. 11480 (1975).					
FS Date: 1/14/2014

Concrete headwall on LS toe.

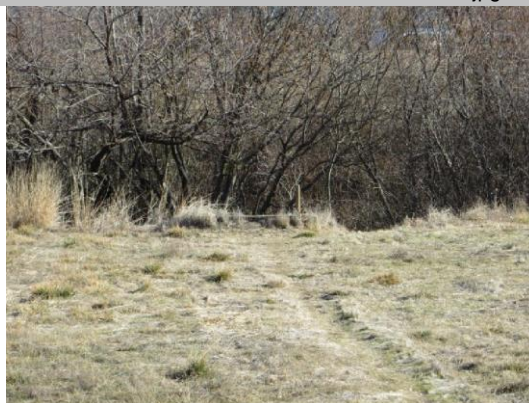
Photo 3 of 3 : UCIP_SP_2017_27199_50387.jpg

Concrete headwall and flapgate visible on waterside berm

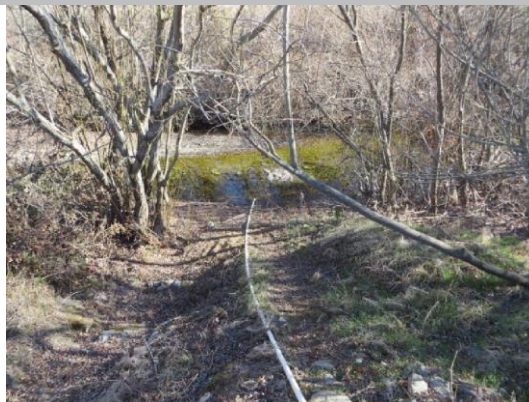
Photo 2 of 3 : UCIP_SP_2017_27563_51181.jpg

Pipe visible just downstream from stormdrain.

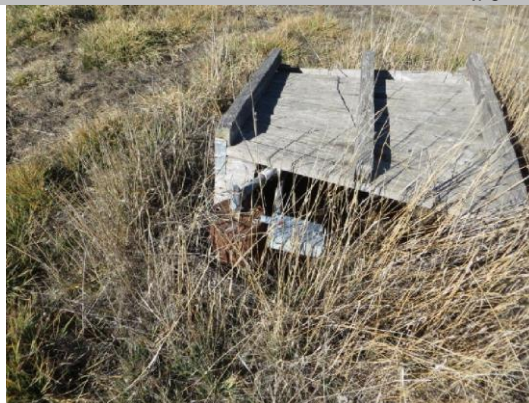
Photo 1 of 3 : UCIP_SP_2017_51435_50393.jpg

FS_ID:51435
DS_ID:21209
EP_NO: 8513
Repair Type: Urgent
Crossing Status: Found
UCIP Comments: 11/30/2016 Pipe not in use per LMA representative, Scott Webb. DWR Fall inspection 2016 indicated depression along pipe alignment. According to LMA representative the new property owner is Tracy Joe Hill. Need to contact owner. New owner will need to coordinate with CVFPB regarding permit name change and to address depression noted in the 2016 DWR Fall Inspection . (O. Magana - DWR UCIP)01/14/2014 Appears pipe is leaking on WS toe of Levee at mud pit. (W. Wylie - DWR UCIP)
FIELD_STRUCT_DESC: 1 of 2: 1.25-inch steel groundwater pipe through the levee, 2 feet below the levee. Steel cutoff wall around pipe at center of levee. Well with 8-inch casing on waterside (WS) slope. (1.25-inch water pipe and 0.75-inch electrical conduit authorized under Permit No. 8513, 1974 - Fisher)
FS Date: 11/30/2016

Pump and pipe visible at wooden box on WS berm.

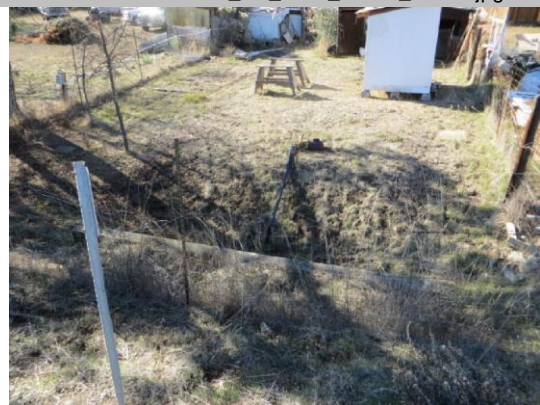
Photo 1 of 3 : UCIP_SP_2017_27208_50411.jpg

LM Start	0.55	Rating **	M	Issue No.	38
LM End	0.55	Issue Type +	Ma	Location *	LS
Category	Supplemental			GPS Latitude/Longitude	
				Start	End
Item	DWR UCIP LMA Responsibility			39.183130 °	39.183130 °
				-122.912198 °	-122.912198 °
DWR ID					
Comment Code					
Inspector Comment					
FS_ID:27208					
DS_ID:21210					
EP_NO: 11482					
Repair Type: Non-Urgent					
Crossing Status: Found					
UCIP Comments: Fence on LS slope creates access issue.					
FIELD_STRUCT_DESC: 36-inch CM drainpipe through the levee, 9.0 feet below the crown. Flap gate on the waterward end. Concrete headwalls on both ends. (USACE-1961). This entry matches the Drainage or Irrigation Structure referenced in O&M manual (HLM 0.54). This pipe was retained under ABO No. 11482 (1975).					
FS Date: 1/14/2014

Concrete headwall on LS toe.

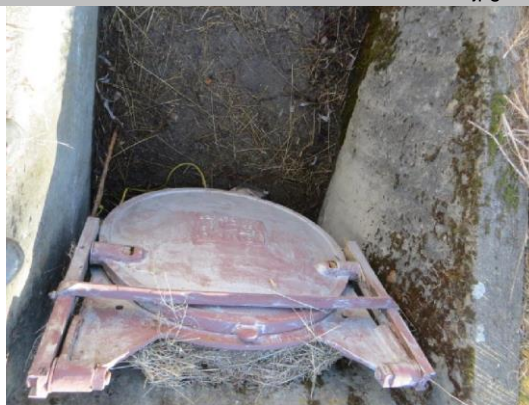
Photo 3 of 3 : UCIP_SP_2017_27208_50409.jpg

Flapgate and concrete headwall on WS berm.

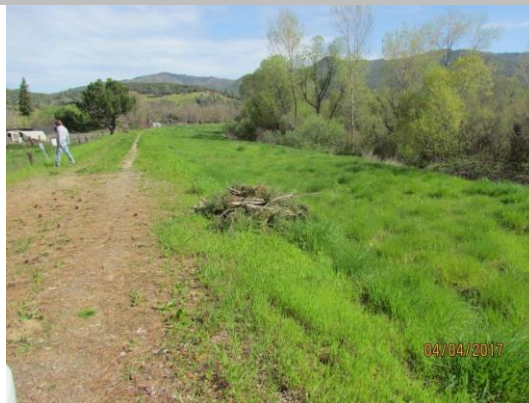
Photo 1 of 1 : SP_2017_NA0009_4_30_20170410_00049.jpg

LM Start	0.56	Rating **	M	Issue No.	30
LM End	0.56	Issue Type +	En	Location *	WS
Category	Earthen Levee			GPS Latitude/Longitude	
				Start	End
Item	Encroachments			39.182940 °	39.182940 °
				-122.912142 °	-122.912142 °
DWR ID	DWR_NA0009_02_s_2017_30				
Comment Code					
PR : Prunings					
Inspector Comment					
Remove the prunings from the waterside slope.

View of the prunings along the waterside slope.

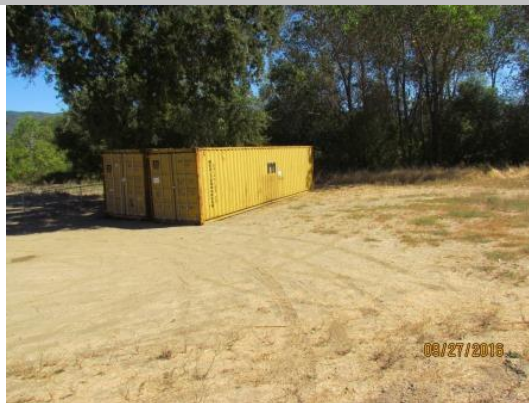
Photo 1 of 1 : SP_2017_NA0009_4_25_20170315_00012.jpg

LM Start	0.96	Rating **	M	Issue No.	25
LM End	0.96	Issue Type +	En	Location *	WS
Category	Earthen Levee			GPS Latitude/Longitude	
				Start	End
Item	Encroachments			39.177249 °	39.177249 °
				-122.913619 °	-122.913619 °
DWR ID	DWR_NA0009_02_f_2016_25				
Comment Code					
BU : Building					
Inspector Comment					
Two 40' shipping containers in the flood way need to be removed.

View of the shipping container in the floodway.

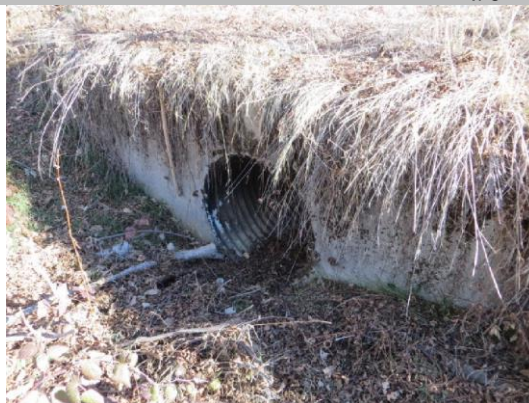
Photo 1 of 3 : UCIP_SP_2017_27583_51202.jpg

LM Start	1.03	Rating **	A/W	Issue No.	39
LM End	1.03	Issue Type +	Ma	Location *	LS
Category	Supplemental			GPS Latitude/Longitude	
				Start	End
Item	DWR UCIP LMA Responsibility			39.176366 °	39.176366 °
				-122.913509 °	-122.913509 °
DWR ID					
Comment Code					
Inspector Comment					
FS_ID:27583 DS_ID:21211 EP_NO: 11486 Repair Type: No Action Needed Crossing Status: Found UCIP Comments: FIELD_STRUCT_DESC: 36-inch CM drainpipe through the levee, 7.3 feet below the crown. Flap gate on the waterward end. Concrete headwalls on both ends. Splash apron broken off on the waterward end. (USACE-1961). This entry matches the Drainage or Irrigation Structure referenced in O&M manual (HLM 1.21). This pipe was retained under ABO No. 11486 (1975). USACE O&M DWG No. CC-4-4-29. FS Date: 1/22/2014

Pipe visible at concrete inlet on LS toe.

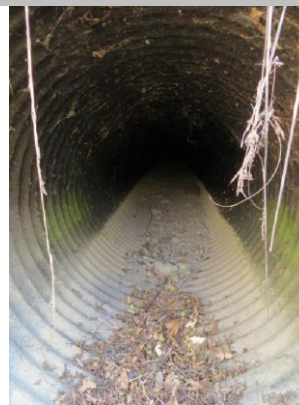
Photo 2 of 3 : UCIP_SP_2017_27583_51201.jpg

Pipe as visible from LS toe.

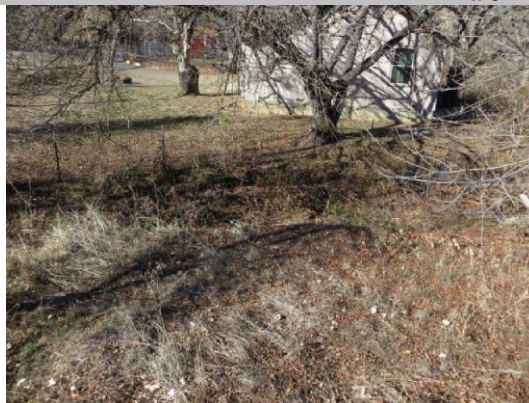
Photo 3 of 3 : UCIP_SP_2017_27583_51200.jpg

Pipe visible on LS toe.

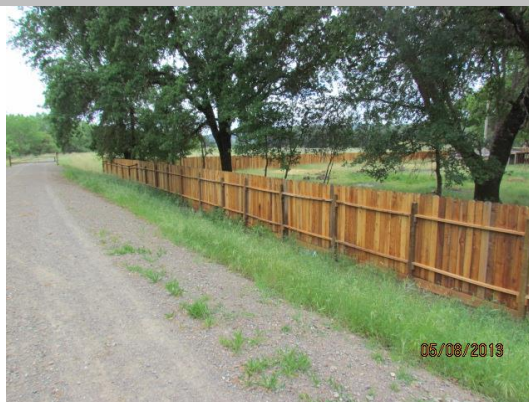
Photo 1 of 1 : SP_2017_NA0009_4_10_20170315_00007.jpg

LM Start	1.09	Rating **	U	Issue No.	10
LM End	1.11	Issue Type +	En	Location *	LS
Category	Earthen Levee			GPS Latitude/Longitude	
				Start	End
Item	Encroachments			39.175460 °	39.175075 °
				-122.913400 °	-122.913392 °
DWR ID	DWR_NA0009_02_s_2013_10				
Comment Code					
FE : Fence					
Inspector Comment

View of the unauthorized fence along the landside toe.

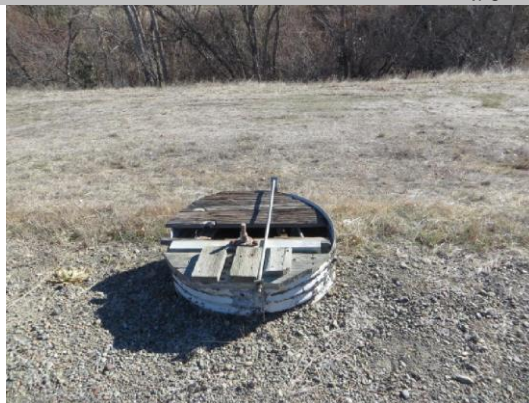
Photo 1 of 3 : UCIP_SP_2017_42994_51214.jpg

LM Start	1.16	Rating **	M	Issue No.	40
LM End	1.16	Issue Type +	Ma	Location *	LS
Category	Supplemental			GPS Latitude/Longitude	
				Start	End
Item	DWR UCIP LMA Responsibility			39.174370 °	39.174370 °
				-122.913543 °	-122.913543 °
DWR ID					
Comment Code					
Inspector Comment					
FS_ID:42994 DS_ID:21212 EP_NO: 11483 Repair Type: Non-Urgent Crossing Status: Found UCIP Comments: Pipe appears abandoned and if so, should be done so properly. Debris blocking flapgate at outlet. FIELD_STRUCT_DESC: *ABANDONED* 30-inch CM drainpipe through the levee, 17.8 feet below the crown. Slide gate in 44-inch diameter CMP riser waterward slope. Flap gate on the waterward end at concrete headwall. 6'X8' concrete sump at landward toe. (USACE-1961). Originally included in O&M manual (HLM 1.22). This pipe was retained under ABO No. 11483 (1975). FS Date: 1/22/2014

Slide gate in 44-inch CMP riser on WS shoulder.

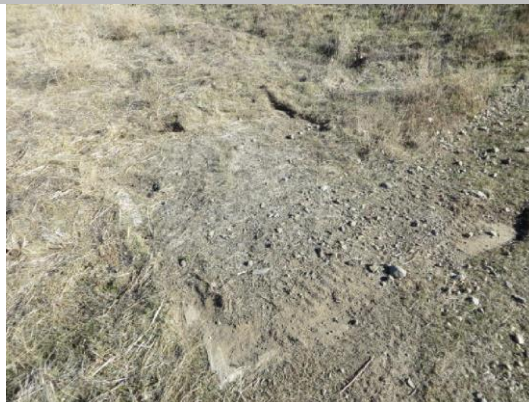
Photo 2 of 3 : UCIP_SP_2017_42994_51213.jpg

6'X8' concrete sump filled in with soil, visible at LS toe.

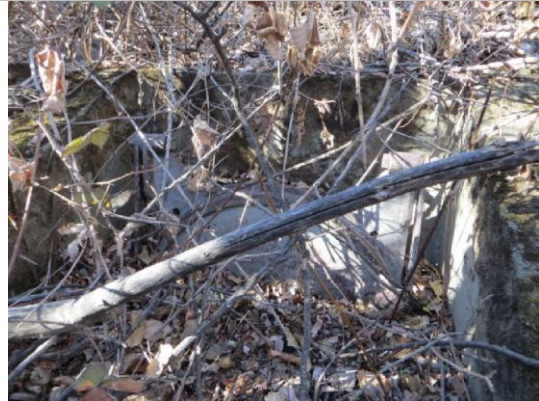
Photo 3 of 3 : UCIP_SP_2017_42994_51215.jpg

Flapgate and concrete headwall visible off WS berm.

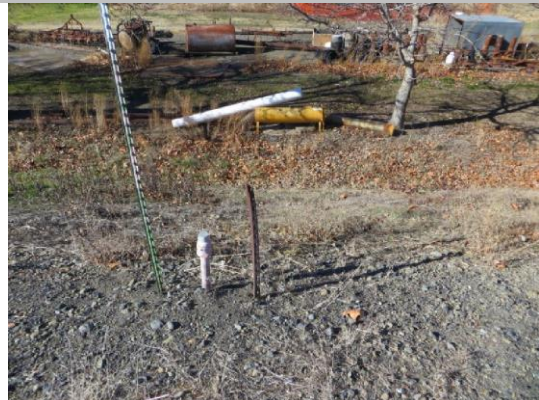
Photo 1 of 2 : UCIP_SP_2017_27606_51250.jpg

LM Start	1.70	Rating **	M	Issue No.	41
LM End	1.70	Issue Type +	En	Location *	LS
Category	Supplemental			GPS Latitude/Longitude	
				Start	End
Item	DWR UCIP Field Study			39.167156 °	39.167156 °
				-122.916610 °	-122.916610 °
DWR ID					
Comment Code					
Inspector Comment					
FS_ID:27606					
DS_ID:21214					
EP_NO: 15825					
Repair Type: Non-Urgent					
Crossing Status: Found					
UCIP Comments: Pipe with closure device not visible on WS toe. Clear soil from pipe and cover for better verification of closure.					
FIELD_STRUCT_DESC: 8-inch steel pipe through the levee, 2.0 feet below the crown. Siphon breaker on apex of pipe at landward shoulder. Exposed filter at landward slope. Seasonal pump on waterward slope. (Permit No. 15825-1992)					
FS Date: 1/22/2014

Vent on LS shoulder with filter visible on LS toe.

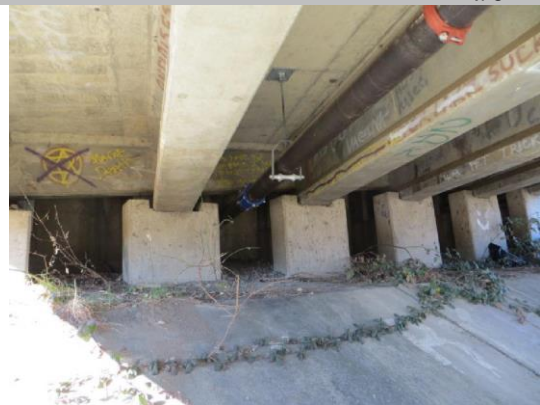
Photo 1 of 2 : UCIP_SP_2017_27624_51263.jpg

LM Start	1.96	Rating **	M	Issue No.	43
LM End	1.96	Issue Type +	En	Location *	LS
Category	Supplemental			GPS Latitude/Longitude	
				Start	End
Item	DWR UCIP Field Study			39.163414 °	39.163414 °
				-122.916741 °	-122.916741 °
DWR ID					
Comment Code					
Inspector Comment					
FS_ID:27624					
DS_ID:21243					
EP_NO: 15865					
Repair Type: Non-Urgent					
Crossing Status: Found					
UCIP Comments: Permit number likely revised from 15865. Verify with inspector and modify entry as required.					
FIELD_STRUCT_DESC: 8-inch steel sewer line (pressurized) through the levee, 3.0 feet below the crown. Cutoff wall around pipe at center of levee. Siphon breaker on waterward levee shoulder. Pipe visible under bridge (Permit No. 15865-1991).					
FS Date: 1/22/2014

Pipe visible under bridge.

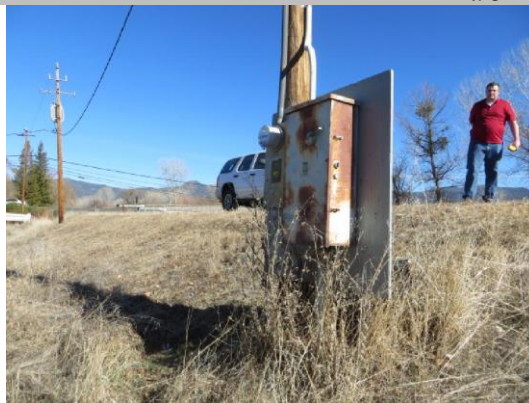
Photo 2 of 2 : UCIP_SP_2017_27629_51279.jpg

LM Start	2.00	Rating **	M	Issue No.	44 (cont)	
LM End	2.00	Issue Type +	En	Location *	LS	
Category	Supplemental			GPS Latitude/Longitude		
				Start	End	
Item	DWR UCIP Field Study			39.162753 °	39.162753 °	
				-122.916811 °	-122.916811 °	
DWR ID						
Comment Code						
Inspector Comment						
FS_ID:27629						
DS_ID:21250						
EP_NO: 17191						
Repair Type: Non-Urgent						
Crossing Status: Found						
UCIP Comments: Appears abandoned, if so it should be done so properly.						
FIELD_STRUCT_DESC: 2 of 2: 2-inch PVC pipe through the levee, 2.0 feet below the crown. Well and electric pump at waterward toe. Pole and meter(Permit No. 17191-2000)						
FS Date: 1/22/2014

Meter and control on LS slope next to pole.

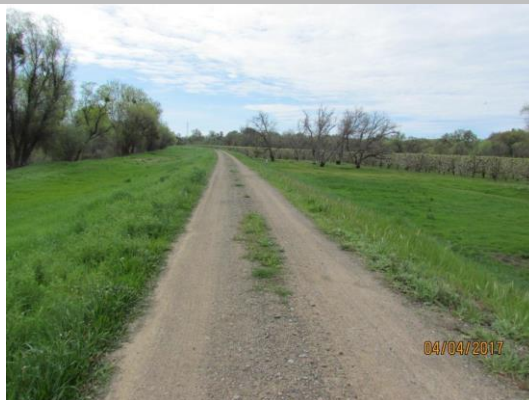
Photo 1 of 1 : SP_2017_NA0009_4_31_20170410_00050.jpg

LM Start	2.70	Rating **	A	Issue No.	31
LM End	2.70	Issue Type +	Ma	Location *	LS
Category	Earthen Levee			GPS Latitude/Longitude	
				Start	End
Item	Vegetation			39.153202 °	39.153202 °
				-122.915672 °	-122.915672 °
DWR ID	DWR_NA0009_02_s_2017_31				
Comment Code					
V1 : Control annual grass and weeds on the levee slopes and easements.					
Inspector Comment					
There are native grasses on both slopes.

View of the native grasses on both slopes.

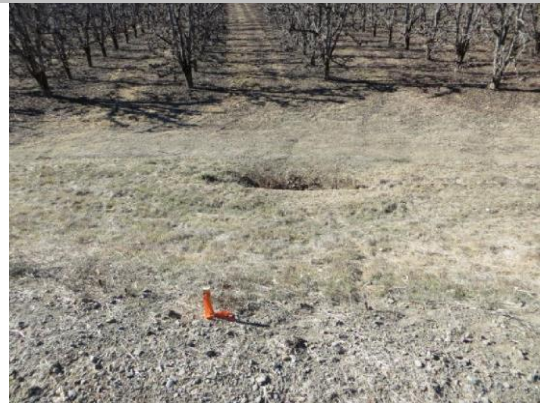
Photo 1 of 3 : UCIP_SP_2017_27630_51283.jpg

LM Start	2.84	Rating **	M	Issue No.	45
LM End	2.84	Issue Type +	Ma	Location *	LS
Category	Supplemental			GPS Latitude/Longitude	
				Start	End
Item	DWR UCIP LMA Responsibility			39.151257 °	39.151257 °
				-122.914908 °	-122.914908 °
DWR ID					
Comment Code					
Inspector Comment					
FS_ID:27630 DS_ID:21215 EP_NO: 11481 Repair Type: Non-Urgent Crossing Status: Found UCIP Comments: Soil partially blocking inlet and outlet. FIELD_STRUCT_DESC: 24-inch CM drainpipe through the levee, 12.0 feet below the crown. Flap gate on the waterward end. Concrete headwalls on both ends. (USACE-1961). This entry matches the Drainage or Irrigation Structure referenced in O&M manual (HLM 2.93). This pipe was retained under ABO No. 11481 (1975). FS Date: 1/22/2014

Concrete headwall and pipe visible at LS toe.

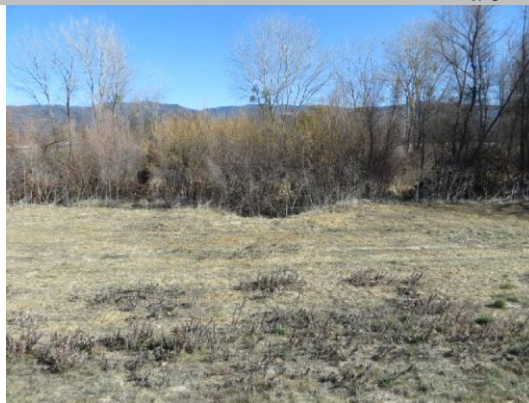
Photo 2 of 3 : UCIP_SP_2017_27630_51282.jpg

Concrete headwall and flapgate visible at WS berm.

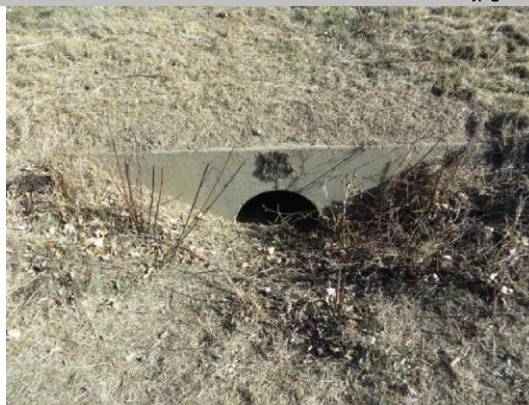
Photo 3 of 3 : UCIP_SP_2017_27630_51281.jpg

Concrete headwall and pipe visible at LS toe.

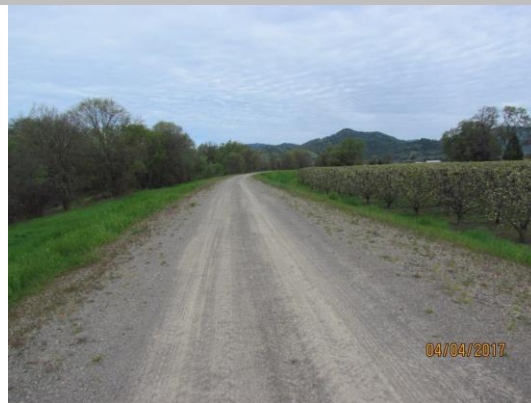
Photo 1 of 1 : SP_2017_NA0009_5_20_20170410_00042.jpg

LM Start	0.24	Rating **	A	Issue No.	20
LM End	0.24	Issue Type +	Ma	Location *	LS
Category	Earthen Levee			GPS Latitude/Longitude	
				Start	End
Item	Vegetation			39.150847 °	39.150847 °
				-122.916367 °	-122.916367 °
DWR ID	DWR_NA0009_03_s_2017_20				
Comment Code					
V1 : Control annual grass and weeds on the levee slopes and easements.					
Inspector Comment					
There are native grasses on both slopes.

View of the native grasses on both slopes.

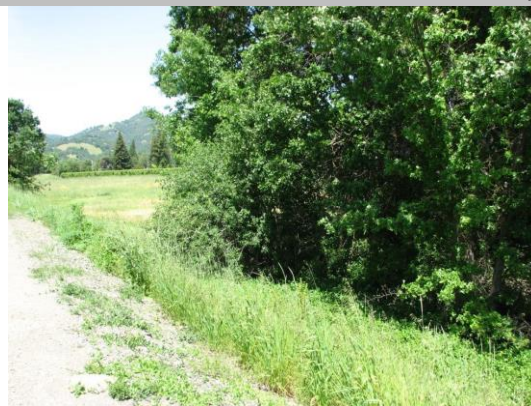
Photo 1 of 1 : SP_2017_NA0009_5_9_20170315_00001.jpg

LM Start	0.49	Rating **	M	Issue No.	9
LM End	0.49	Issue Type +	Ma	Location *	LS
Category	Earthen Levee			GPS Latitude/Longitude	
				Start	End
Item	Vegetation			39.154195 °	39.154195 °
				-122.918134 °	-122.918134 °
DWR ID	DWR_NA0009_03_s_2016_9				
Comment Code					
V2 : Remove the wild growth other than native grasses from the levee slopes.					
Inspector Comment

View of the overgrown trees and vegetation at the landside toe.

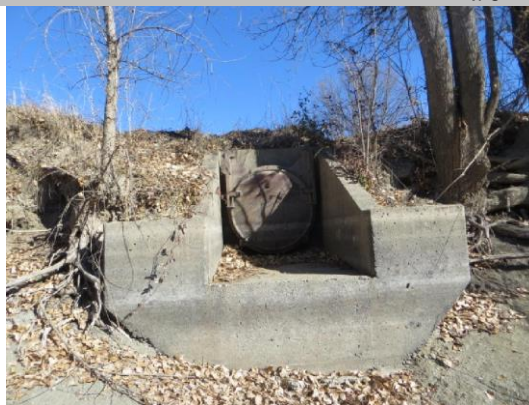
Photo 3 of 3 : UCIP_SP_2017_27863_51540.jpg

Concrete headwall and flapgate visible at WS berm.

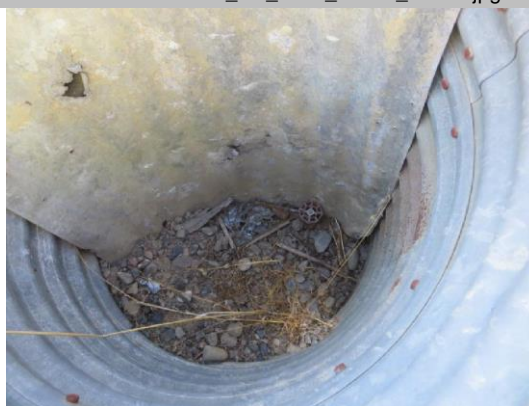
Photo 1 of 3 : UCIP_SP_2017_27891_51587.jpg

LM Start	0.75	Rating **	M	Issue No.	22
LM End	0.75	Issue Type +	En	Location *	LS
Category	Supplemental			GPS Latitude/Longitude	
				Start	End
Item	DWR UCIP Field Study			39.157443 °	39.157443 °
				-122.920110 °	-122.920110 °
DWR ID					
Comment Code					
Inspector Comment					
FS_ID:27891 DS_ID:21219 EP_NO: 11492 Repair Type: Non-Urgent Crossing Status: Indicator Found UCIP Comments: Appears abandoned and if so should be done so properly. FIELD_STRUCT_DESC: 4-inch steel pipe through the levee, 2.5 feet below the crown. Siphon breaker in 24-inch CMP riser on LS shoulder. Pump on concrete platform on waterward side. Hose chute and concrete stairway on waterward slope. This pipe was retained under ABO No. 11492 (1975). FS Date: 1/22/2014

Valve visible at bottom of CMP riser on LS shoulder.

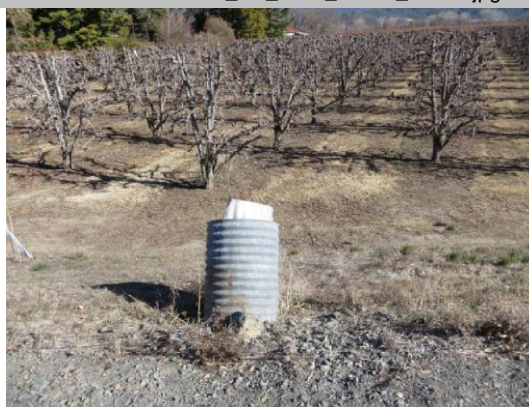
Photo 2 of 3 : UCIP_SP_2017_27891_51586.jpg

Siphon at LS shoulder inside 24-inch CMP riser.

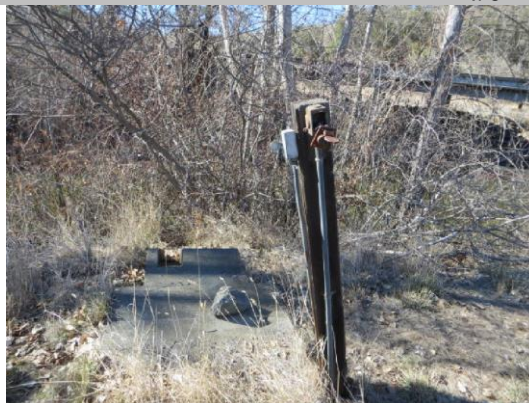
Photo 3 of 3 : UCIP_SP_2017_27891_51585.jpg

LM Start	0.75	Rating **	M	Issue No.	22 (cont)	
LM End	0.75	Issue Type +	En	Location *	LS	
Category	Supplemental			GPS Latitude/Longitude		
				Start		End
Item	DWR UCIP Field Study			39.157443 °		39.157443 °
				-122.920110 °		-122.920110 °
DWR ID						
Comment Code						
Inspector Comment						
FS_ID:27891 DS_ID:21219 EP_NO: 11492 Repair Type: Non-Urgent Crossing Status: Indicator Found UCIP Comments: Appears abandoned and if so should be done so properly. FIELD_STRUCT_DESC: 4-inch steel pipe through the levee, 2.5 feet below the crown. Siphon breaker in 24-inch CMP riser on LS shoulder. Pump on concrete platform on waterward side. Hose chute and concrete stairway on waterward slope. This pipe was retained under ABO No. 11492 (1975). FS Date: 1/22/2014

Concrete pump pad and electrical works visible on WS berm.

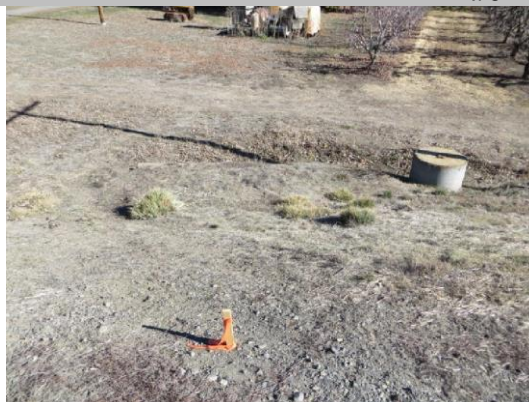
Photo 1 of 3 : UCIP_SP_2017_27892_51591.jpg

LM Start	0.77	Rating **	M	Issue No.	23
LM End	0.77	Issue Type +	Ma	Location *	LS
Category	Supplemental			GPS Latitude/Longitude	
				Start	End
Item	DWR UCIP LMA Responsibility			39.157759 °	39.157759 °
				-122.920301 °	-122.920301 °
DWR ID					
Comment Code					
Inspector Comment					
FS_ID:27892 DS_ID:21220 EP_NO: 11492 Repair Type: Non-Urgent Crossing Status: Found UCIP Comments: Some sediment buildup at inlet. FIELD_STRUCT_DESC: 24-inch CM drainpipe through the levee, 10.0 feet below the crown. Flap gate on the waterward end. Concrete headwalls on both ends. Concrete spillway on waterward slope to bottom of channel. (USACE-1961). This entry matches the Drainage or Irrigation Structure referenced in O&M manual (HLM 0.79). This pipe was retained under ABO No. 11492 (1975). FS Date: 1/22/2014

Concrete headwall visible next to concrete standpipe on LS toe.

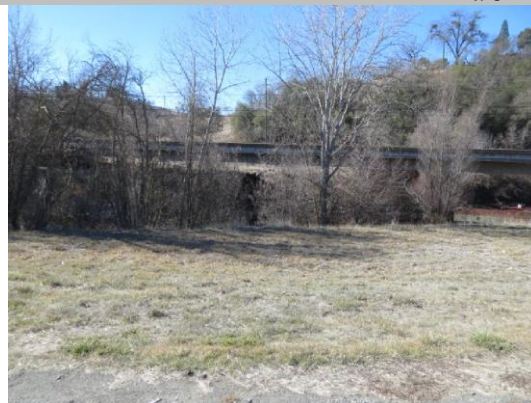
Photo 2 of 3 : UCIP_SP_2017_27892_51590.jpg

Concrete outfall visible off WS berm.

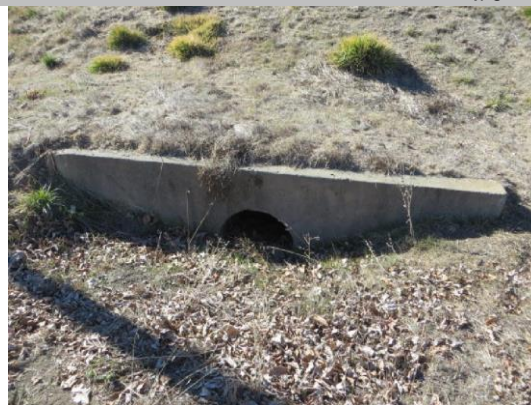
Photo 3 of 3 : UCIP_SP_2017_27892_51589.jpg

Concrete headwall visible at LS toe.

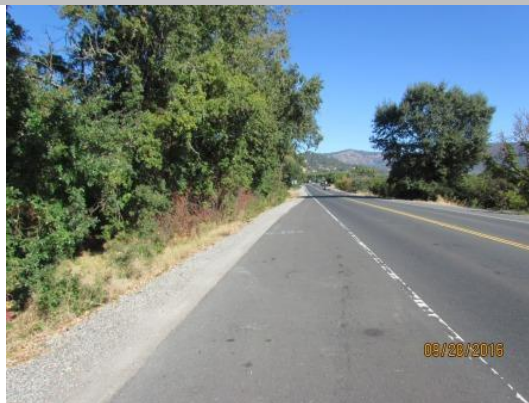
Photo 1 of 1 : SP_2017_NA0009_5_14_20170315_00005.jpg

LM Start	0.84	Rating **	M	Issue No.	14
LM End	0.89	Issue Type +	Ma	Location *	WS
Category	Earthen Levee			GPS Latitude/Longitude	
				Start	End
Item	Trim / Thin Trees			39.158556 °	39.159304 °
				-122.920674 °	-122.920784 °
DWR ID	DWR_NA0009_03_f_2016_14				
Comment Code					
T2 : Thin trees to allow visibility of the ground and room to flood fight.					
Inspector Comment

View of the waterside vegetation looking upstream.

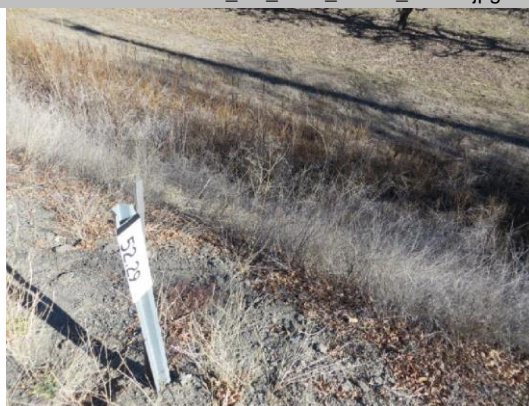
Photo 2 of 3 : UCIP_SP_2017_27893_51594.jpg

LM Start	0.92	Rating **	A/W	Issue No.	24 (cont)
LM End	0.92	Issue Type +	Ma	Location *	WS
Category	Supplemental			GPS Latitude/Longitude	
				Start	End
Item	DWR UCIP LMA Responsibility			39.159628 °	39.159628 °
				-122.920853 °	-122.920853 °
DWR ID					
Comment Code					
Inspector Comment					
FS_ID:27893 DS_ID:21247 EP_NO: N/A Repair Type: No Action Needed Crossing Status: Found UCIP Comments: FIELD_STRUCT_DESC: *Abandoned* 36-inch CM drain pipe through the levee, 10.0 feet below the crown. Plugged with concrete. (USACE-1961). This entry matches the Drainage or Irrigation Structure referenced in O&M manual (HLM 0.90). FS Date: 1/22/2014

Roadway marker 52.29 on LS and WS shoulder mark pipe location on crown.
